STANLEY FASTENING SYSTEMS ENGINEERING LABORATORY

Test Lab No.: 08815-00

Forensic Evaluation of N79WW-1 0356 047

Examine and evaluate N79 WW, tool allegedly involved in an accident with injury to Jonathan Beijar

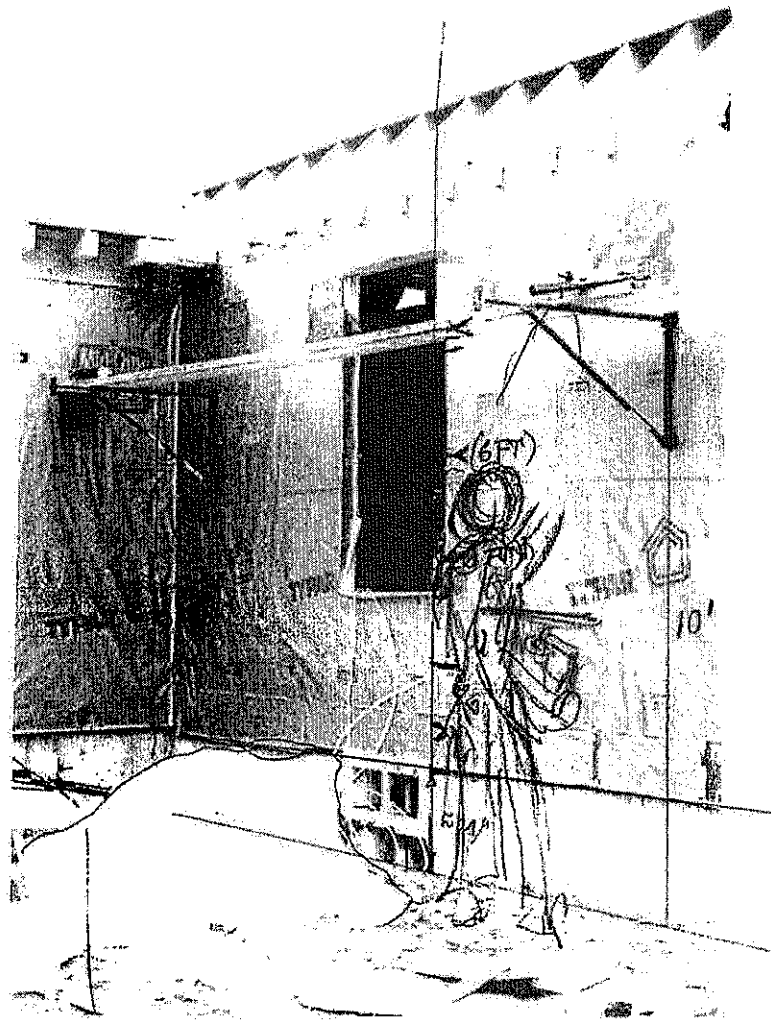
PHOTOS of MANUEL ETC

MOST LIKELY SCENARIO!

TOOL SWINGS DOWN ON HOSE
HE GRABS HOSE ABOVE COMN.
TOOL KEEPS TOWARDS CHEST
FOR ARM/ELBOW HIT TRIGGER
BUT CANNOT PREVENT CHEST
IMPACT
